DINSMORE STORAGE No. 2 DAM

NDI No. PA 00497
PennDER No. 63-20

PHASE I INSPECTION REPORT
NATIONAL DAM INSPECTION PROGRAM

March 1980

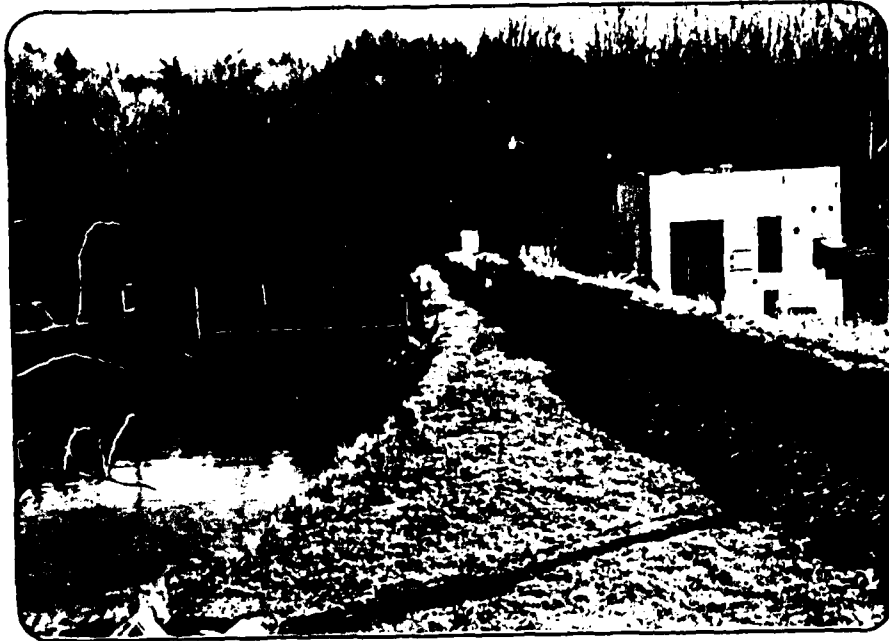
PHOTO 1. View of the Upstream Crest of the Dam from the Right Abutment

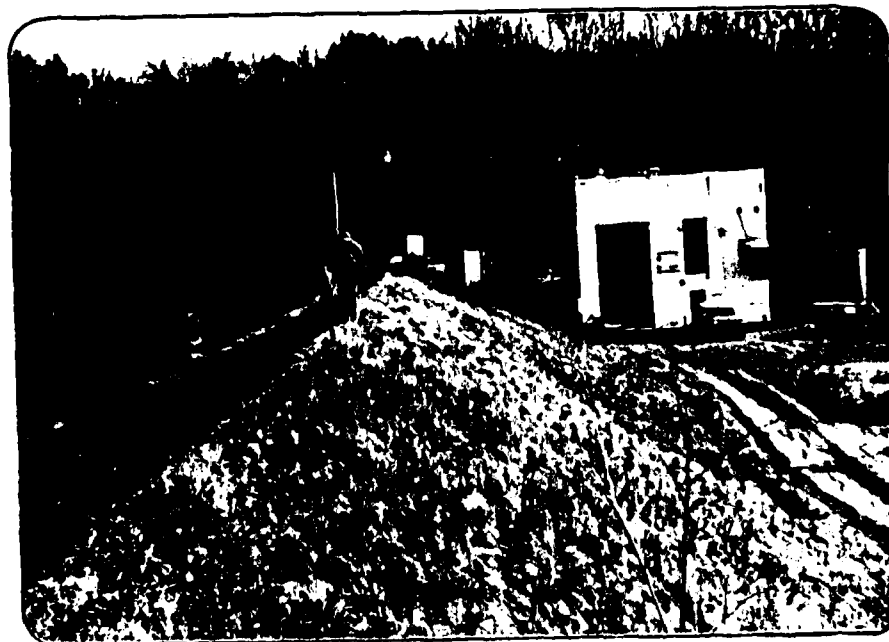
- b. Dam - Seepage was observed flowing from the right downstream toe of the dam. The quantity of seepage was estimated to be less than one gallon per minute (g.p.m.) and migration of fines was not observed. A portion of the exposed areas of the concrete core wall has been repaired; however, the remaining portions not repaired are spalled. The remainder of the spalled areas should be repaired. A minor amount of erosion has occurred along the upstream crest of the embankment. This erosion is superficial in nature and can be retarded by the placement of riprap at these locations. A fuel storage tank has been placed on the downstream slope embankment. It is not known what type of fuel is in the tank, but if it is explosive in nature this tank should be relocated.

PHOTO 2. View of the Downstream Slope of the Dam from the Right Abutment

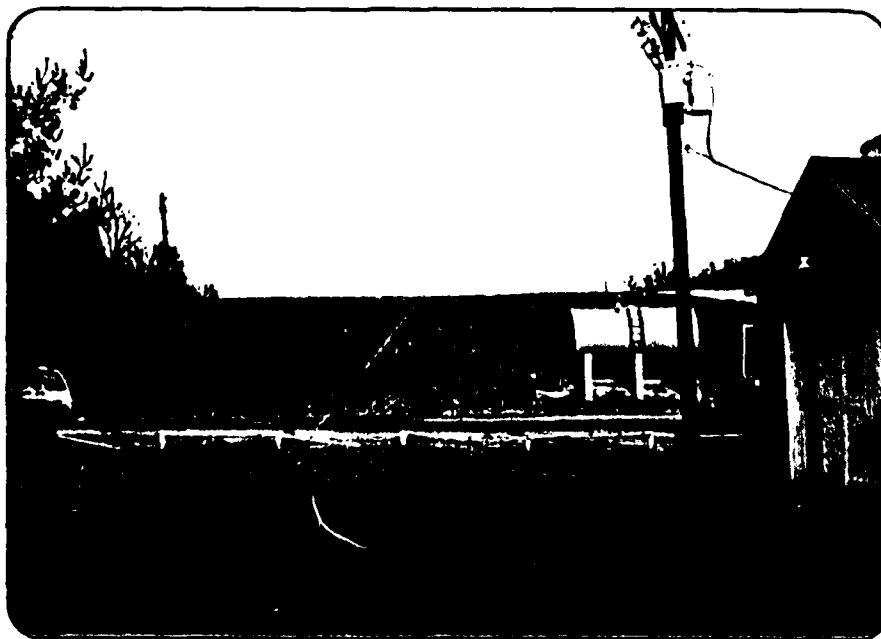
PHOTO 4. View Looking Upstream at the Downstream Slope of the Embankment

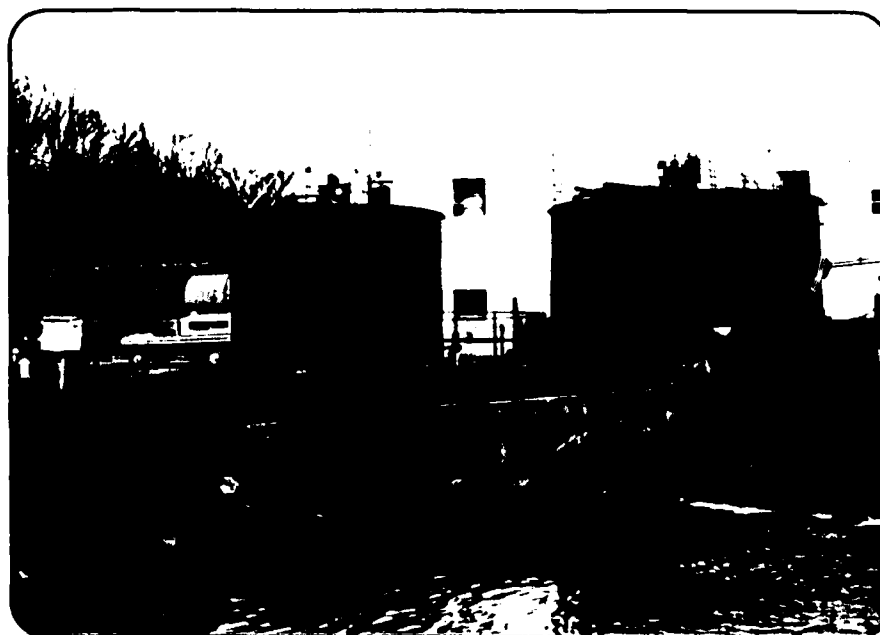
PHOTO 12. View Looking Upstream at the Water Filtration Plant and the Wall Along the Right Side of the Stilling Basin

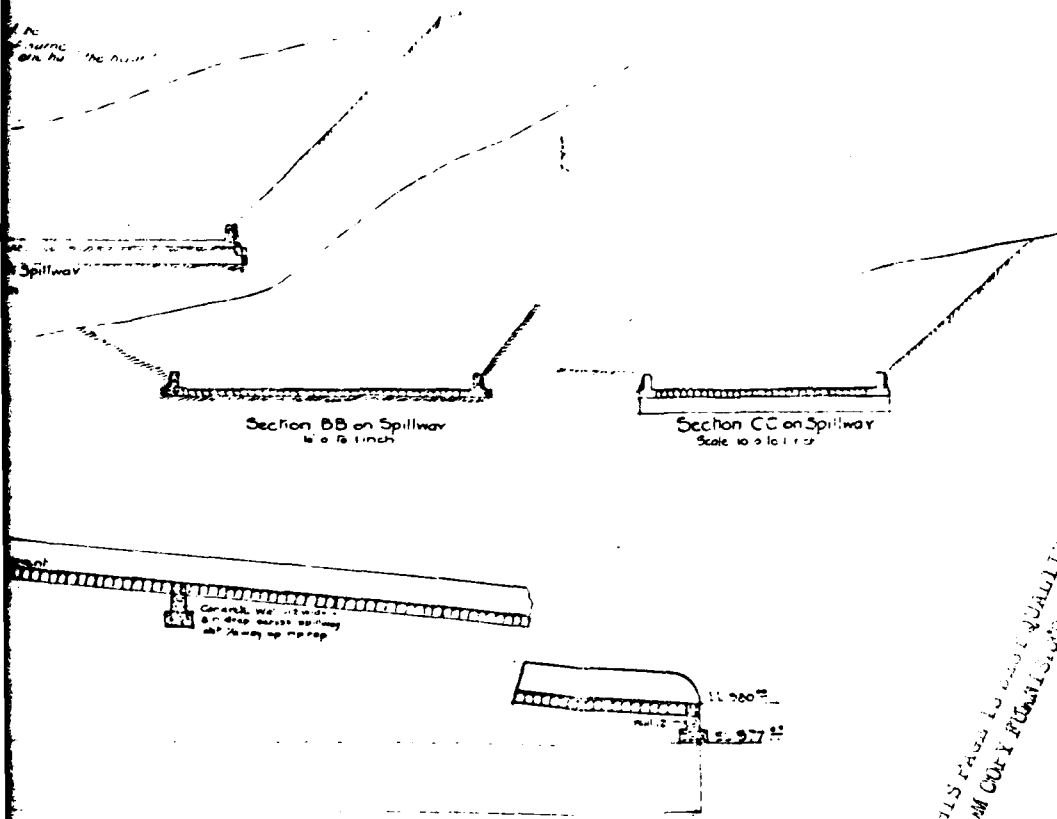
PLATE 4

ITEM	REMARKS
SPILLWAY PLAN	See Plate 3 for design; it is questionable as to whether it represents the "as built" conditions.
SECTIONS and DETAILS	See Plate 4 for design; it may not represent the "as built" conditions.
OPERATING EQUIPMENT PLANS & DETAILS	Abandoned facilities are noted on Plate 3; no information available on current intakes.
